MANUAL PART NUMBER: 400-0442-005

DS801-111

**INTERA COMPUTER/COMPONENT
VIDEO+ STEREO AUDIO
TWISTED PAIR (UTP) RECEIVER**

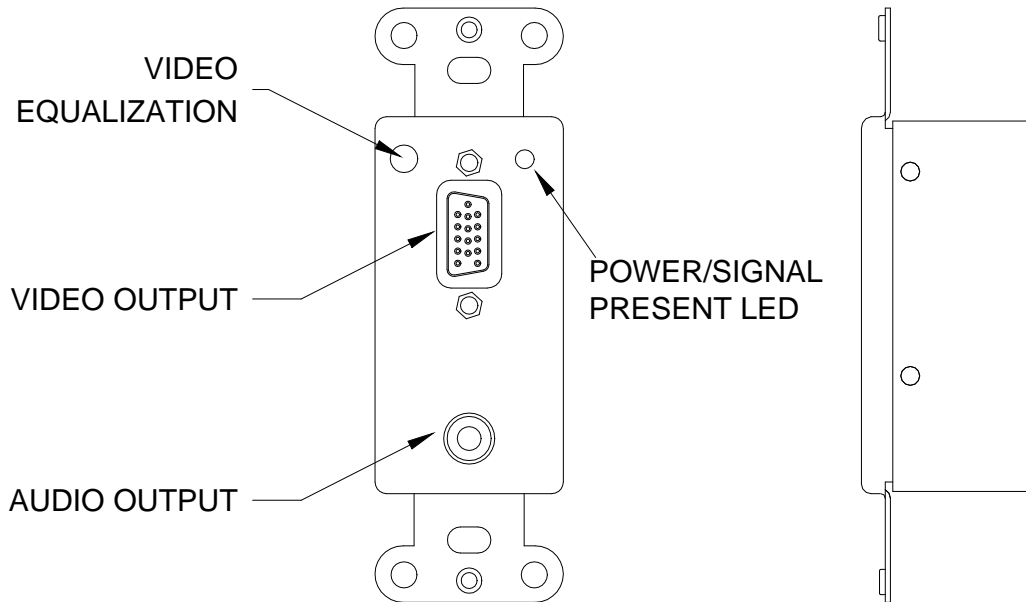
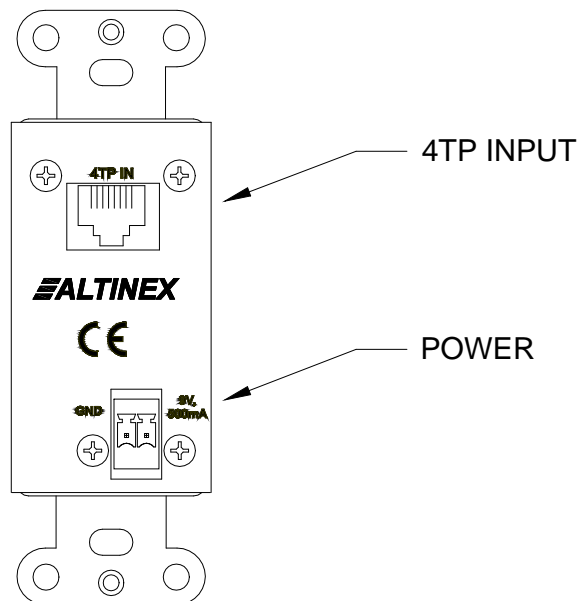
DESCRIPTION OF DS801-111

The **DS801-111** provides both video and stereo audio outputs. The **DS801-111** offers a female 15-pin HD output for RGBHV/YPbPr signals with the native Plug & Play compatibility and a 3.5mm jack is used for the stereo audio output.

The unit also offers video equalization hardware for transmission lengths up to 300 ft (91 m). There is also a signal detect feature which shows when an input signal is present.

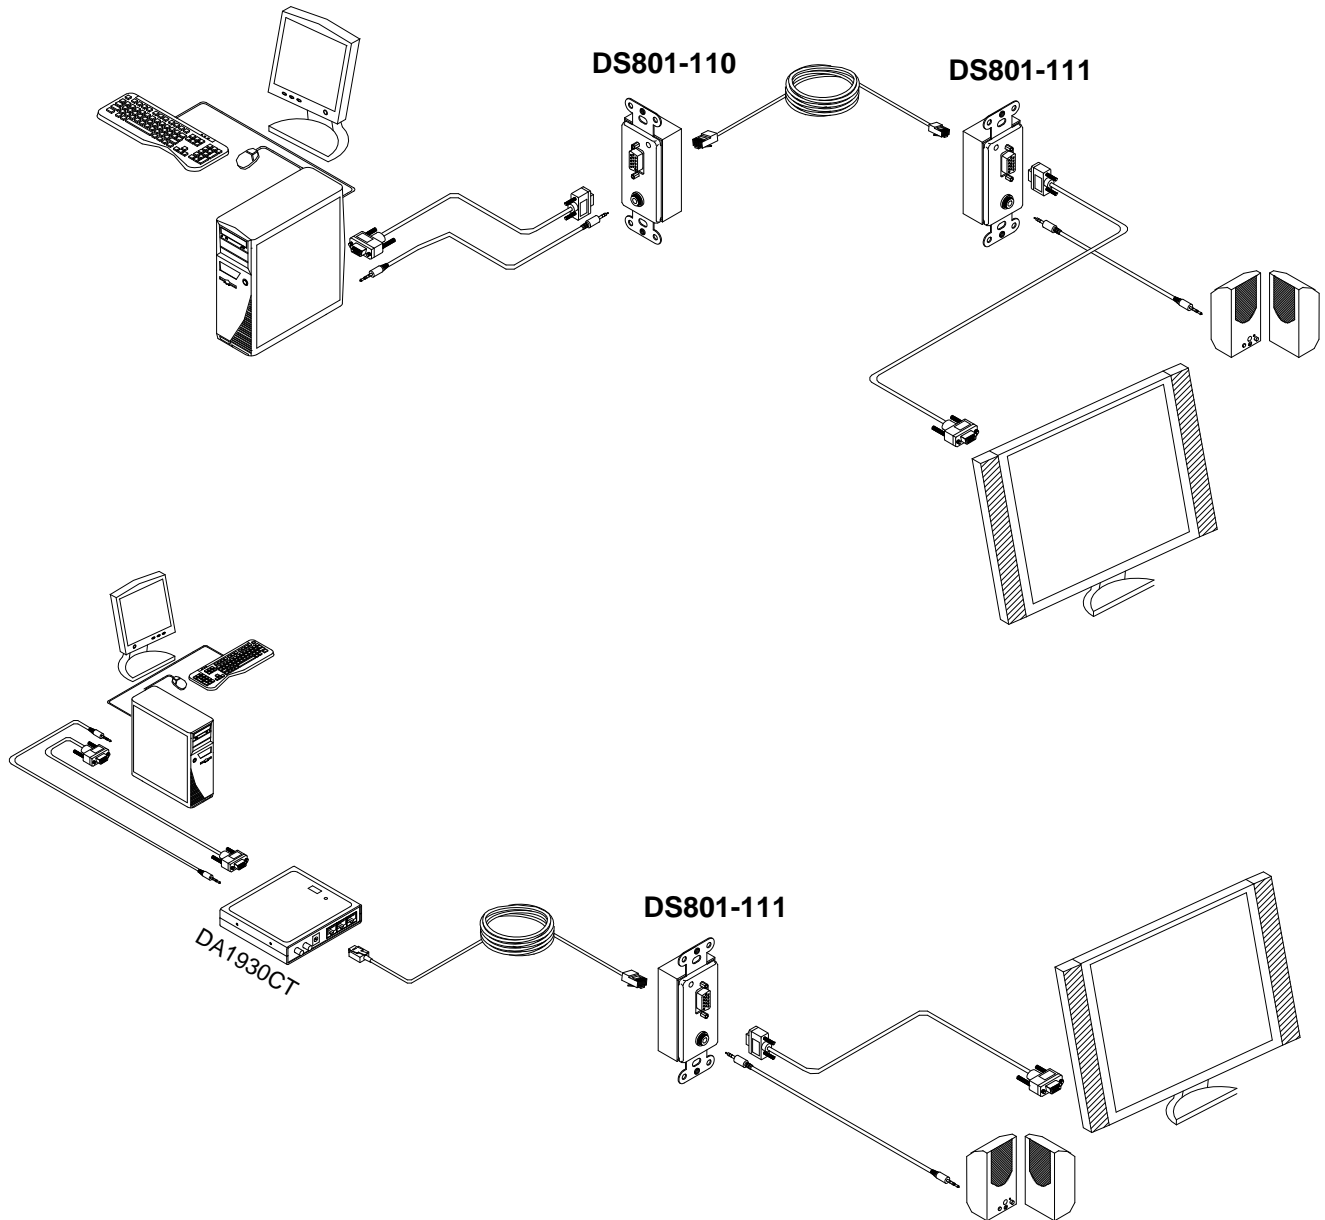
DIAGRAM 1: TYPICAL SETUPS

The **DS801-111** provides a means of receiving computer video and audio signals over Twisted Pair-type (CAT-5/6) cable when used together with a compatible ALTINEX Twisted Pair (UTP) video transmitter, such as the DS801-110 or DA1930CT.

The **DS801-111** is compact and easy to use. The **DS801-111** is able to receive either computer video or component video along with stereo audio transmitted over the UTP cable from the DS801-110 or an equivalent transmitter.

Step 6. Run a UTP-type (CAT-5/CAT-5e) cable from the 4TP INPUT on the **DS801-111** Receiver to the 4TP OUTPUT on the TP Transmitter.
